HO CHIEN ENTERPRISE CO., LTD.Report No.: CE/2004/C1996ANO. 6, LANE 130, SEC. 1, KUANG FU RD., SANDate: 2004/12/21CHUNG CITY, TAIPEI HSIEN 241, TAIWAN, R.O.C.Page: 1 of 2

| <u>Type of Product</u> | : | 1. COPPER ALLOY (6m/m) 2. COPPER ALLOY-NICKEL (6m/m) |

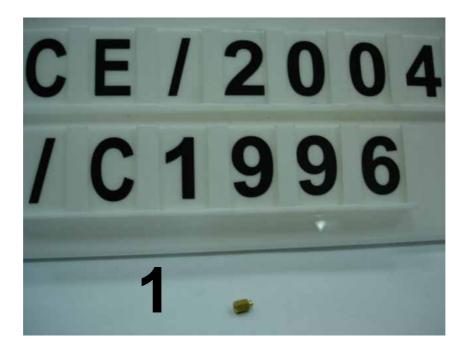
PART NAME NO.1: GOLDEN COLORED METAL (PLEASE REFER TO THE PHOTO ATTACHED)PART NAME NO.2: SILVER COLORED METAL (PLEASE REFER TO THE PHOTO ATTACHED)
